# Service Bulletin-Engine Bearings

## Plain bearing shell terminology

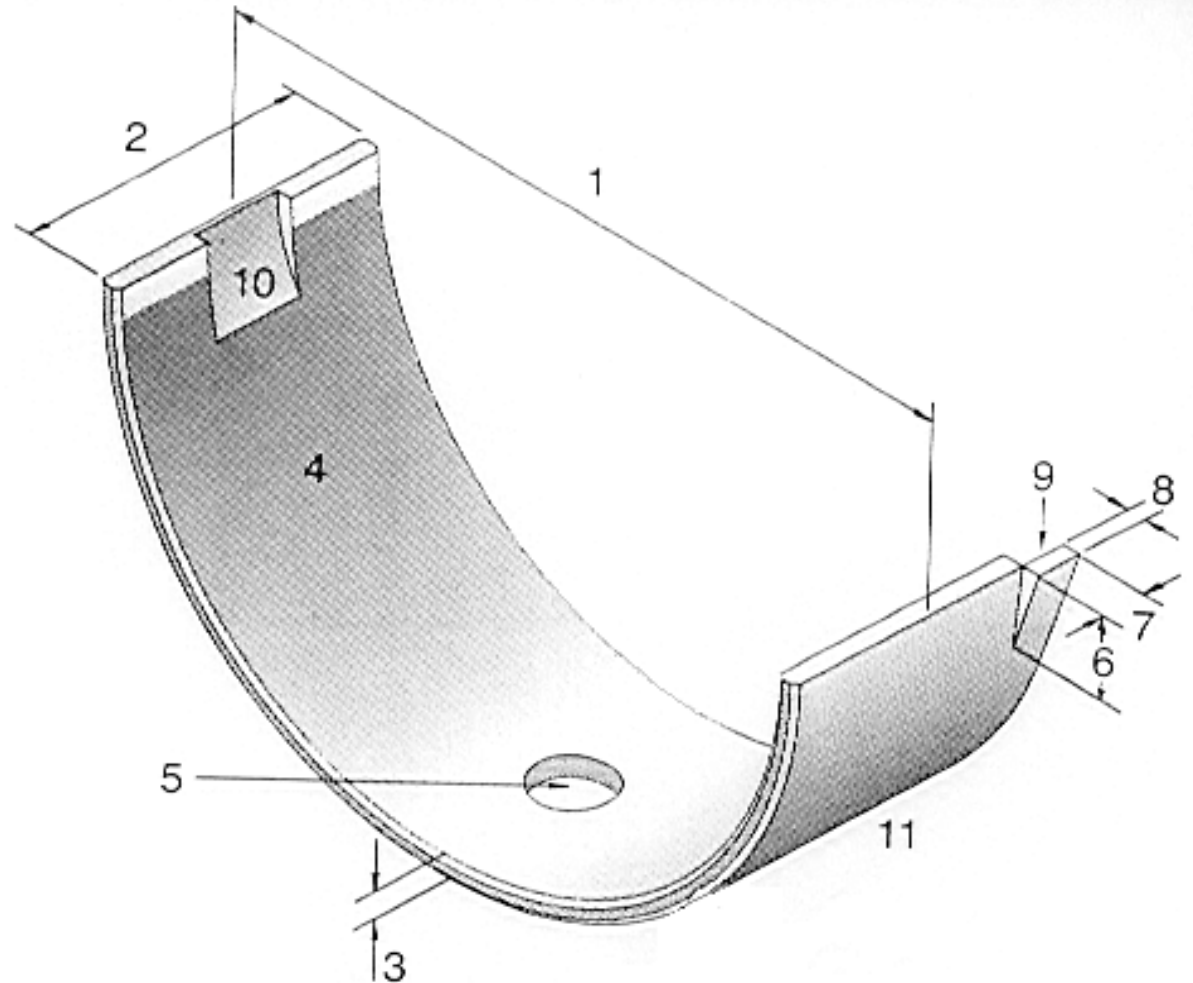
1. Outer diameter
2. Bearing length
3. Wall thickness
4. Overplate
5. Oil - hole
6. Length of lip
7. Width of lip
8. Depth of lip
9. Lip relief
10. Oil-groove

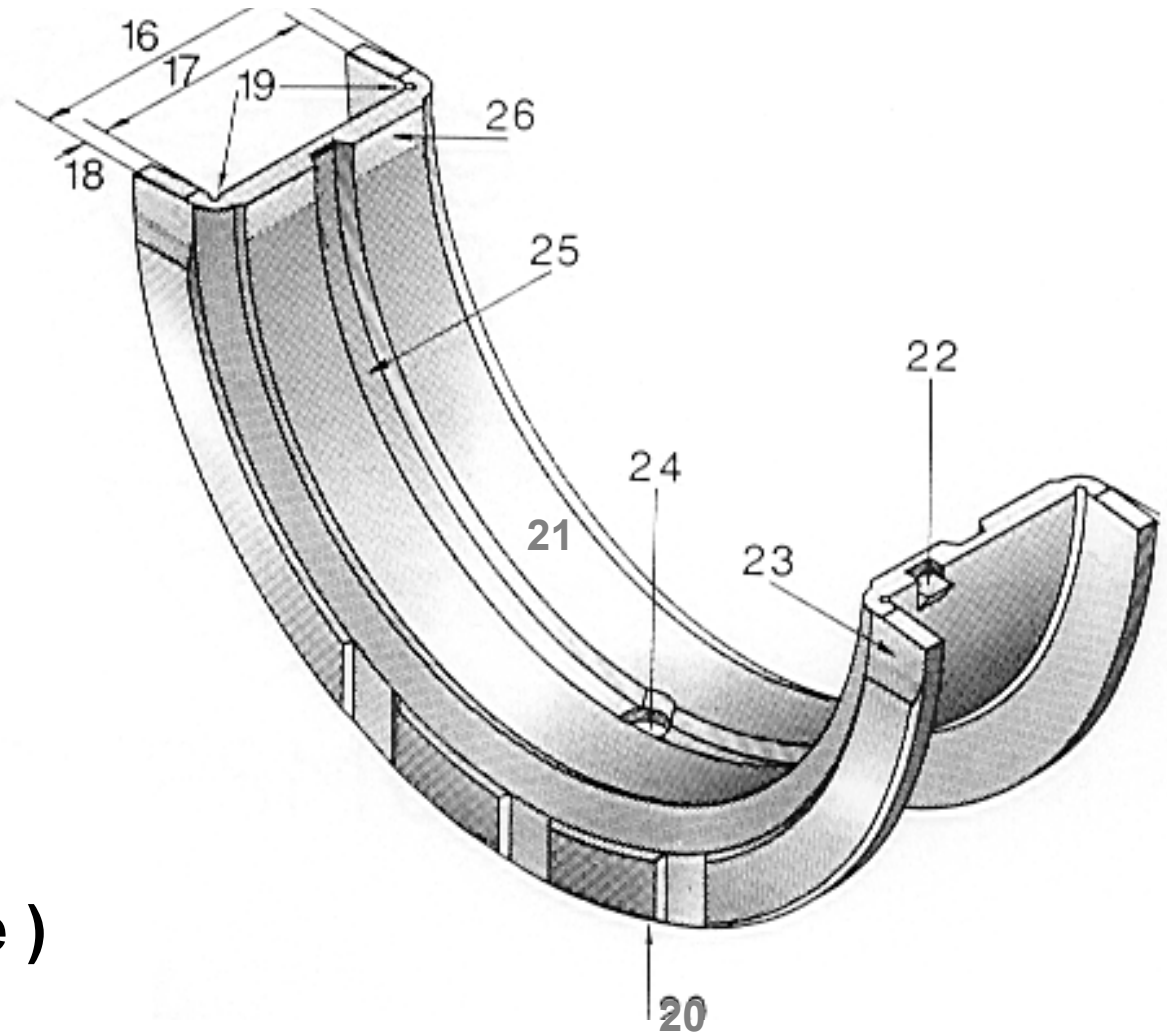
## Thrust bearing terminology

- 16. Length
- 17. Flange distance
- 18. Flange wall-thickness
- 19. Stress reduction reliefs
- 20. Outer flange diameter
- 21. Overplate
- 22. Coined lip
- 23. Joint relief ( thrust face )
- 24. Oil-hole
- 25. Oil-groove
- 26. Joint relief ( inner surface )

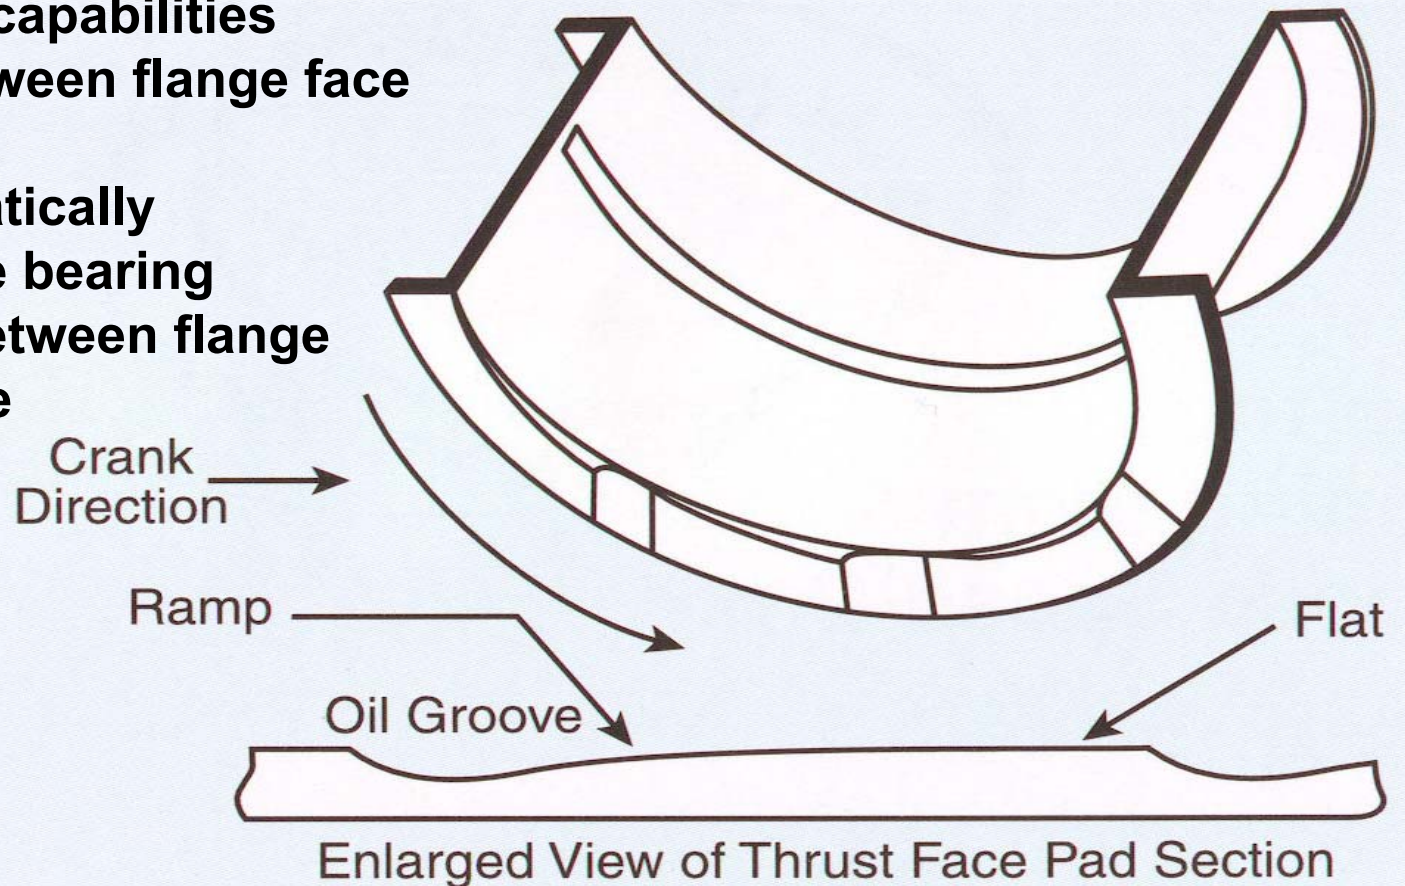
## Design - contoured flange

- Uses a series of formed ramp & flat hydrodynamic profiles on the flange surface to wedge oil via the positively sloped ramp.
- Doubles thrust load capabilities
- Reduces friction between flange face & thrust surface
- Reduces wear dramatically
- Extends life of flange bearing
- Improves lubricity between flange face & thrust surface

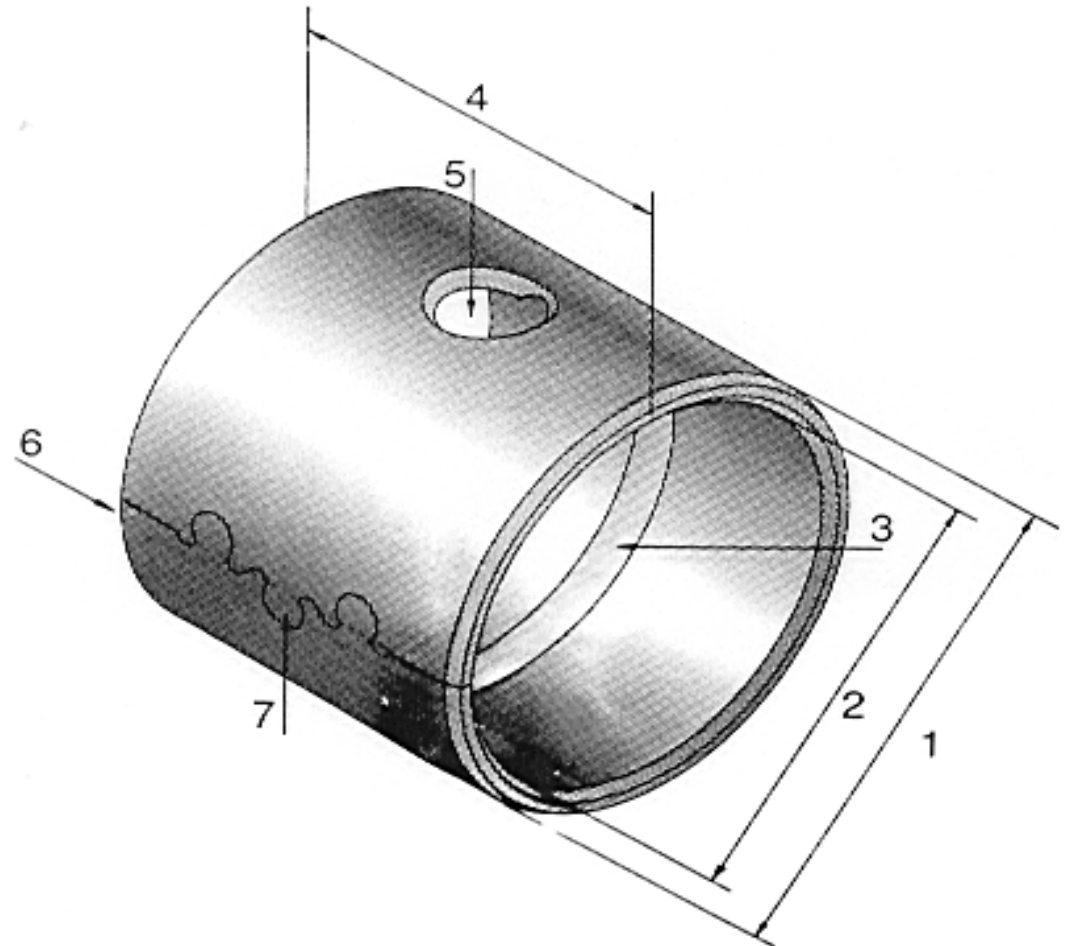
## Small-end bush terminology:

1. Outer diameter
2. Inner diameter
3. Oil-groove
4. Length
5. Oil-hole
6. Joint
7. Clinch or laser weld

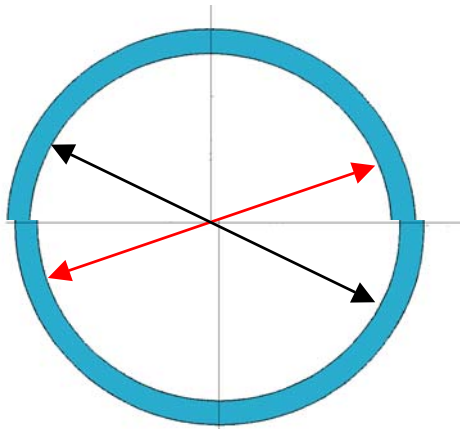
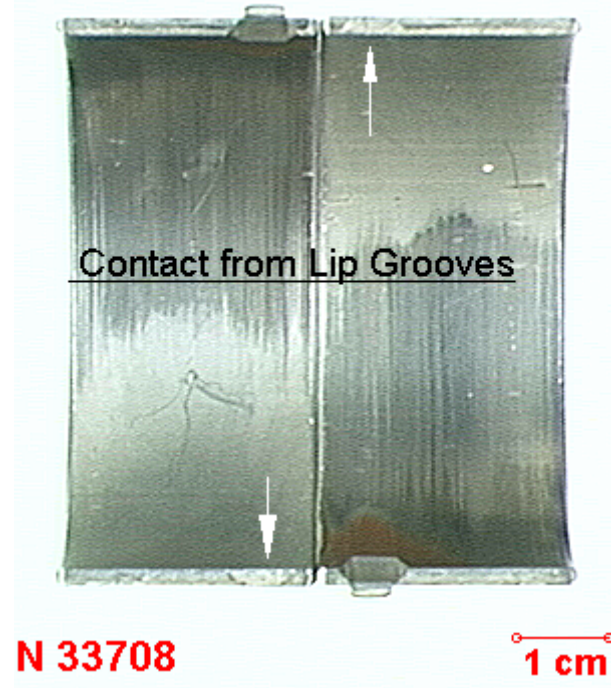
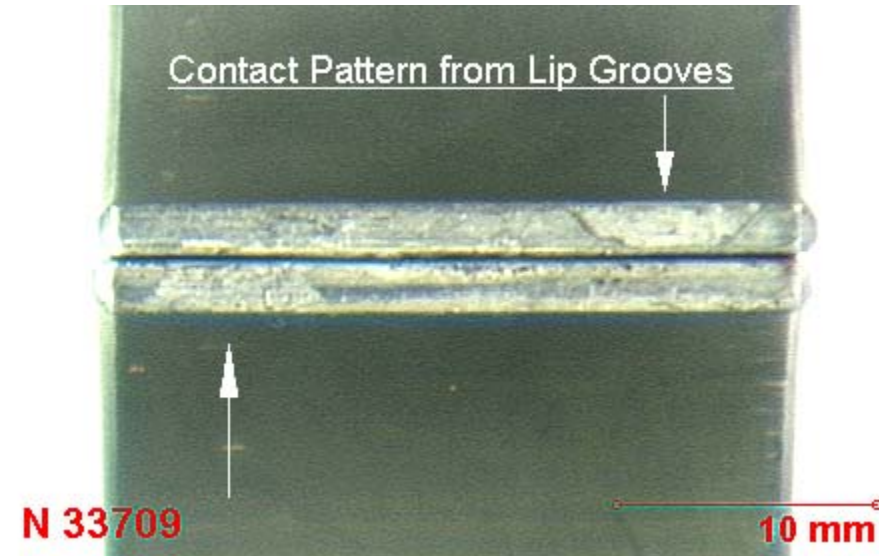
## Wear due to housing cap offset - (shells installed incorrectly)

- Diameter too narrow
- Diameter too wide

### Lip groove contact marks on wrong joint face

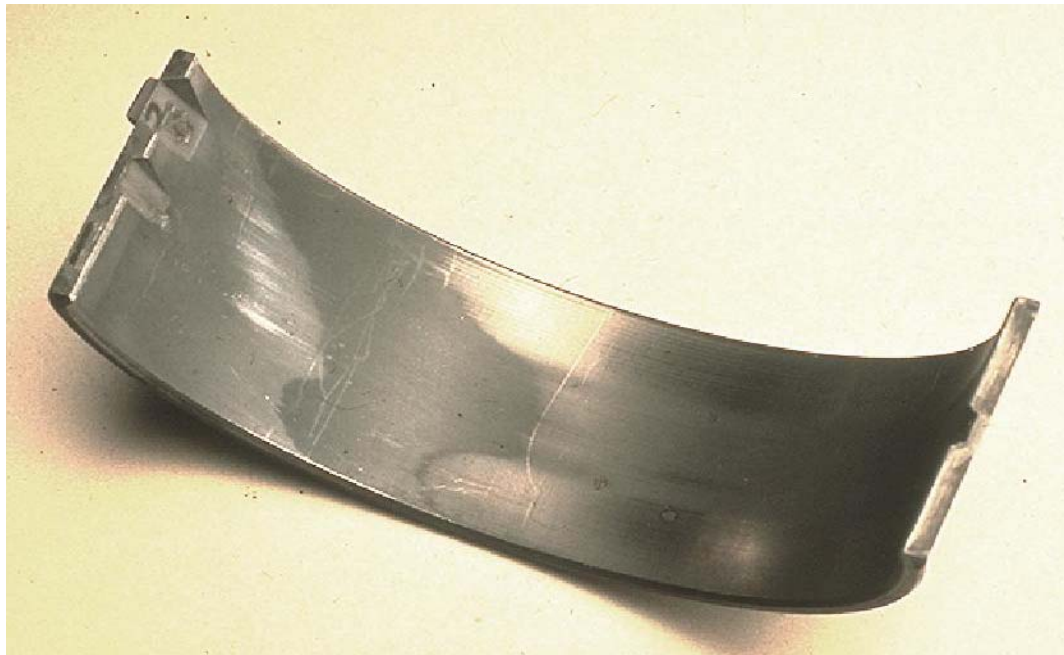
## Overplate wear

**Appearance:** surface (overplate) of bearing worn through, exposing material below.

**Causes:** marginal lubrication, contaminated lubricating oil or blockages/restrictions in oil feed galleries.

**Remedy:** thoroughly flush out engine lubrication system, ensuring that all galleries are free from blockages/debris.

Replace oil and oil filter.

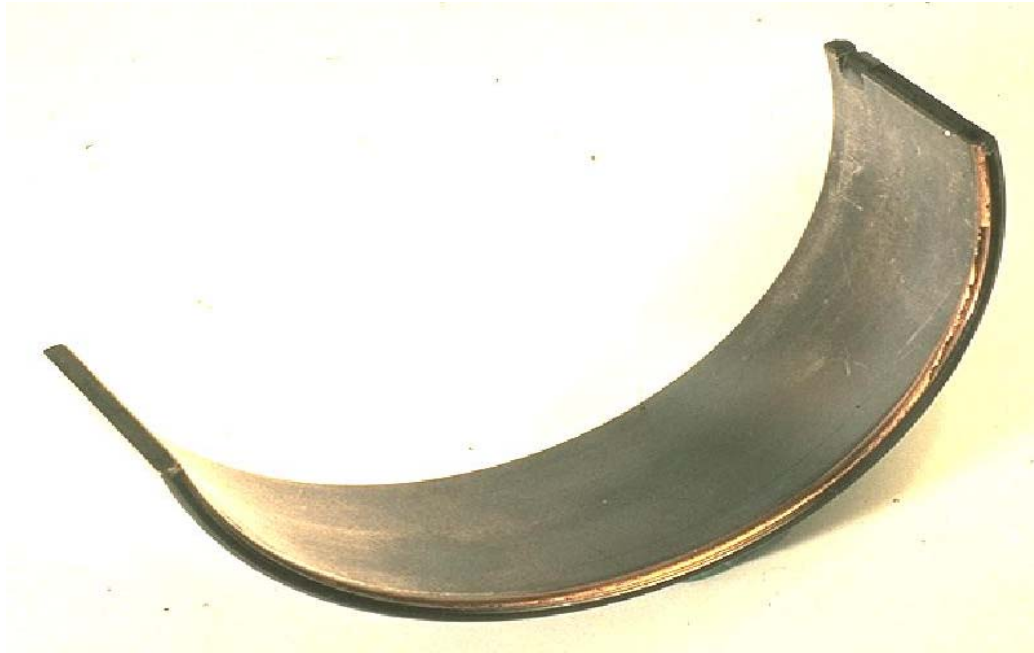
## Edge contact due to incorrect journal fillet radius

**Appearance:** bearing lining and steelback are torn along one or both edges.

**Cause:** Incorrect fillet radii on crankshaft journals.

**Remedy:** Replace all bearings, flush out engine lubrication system, ensuring that all galleries are free from blockages/debris and replace oil and oil filter.

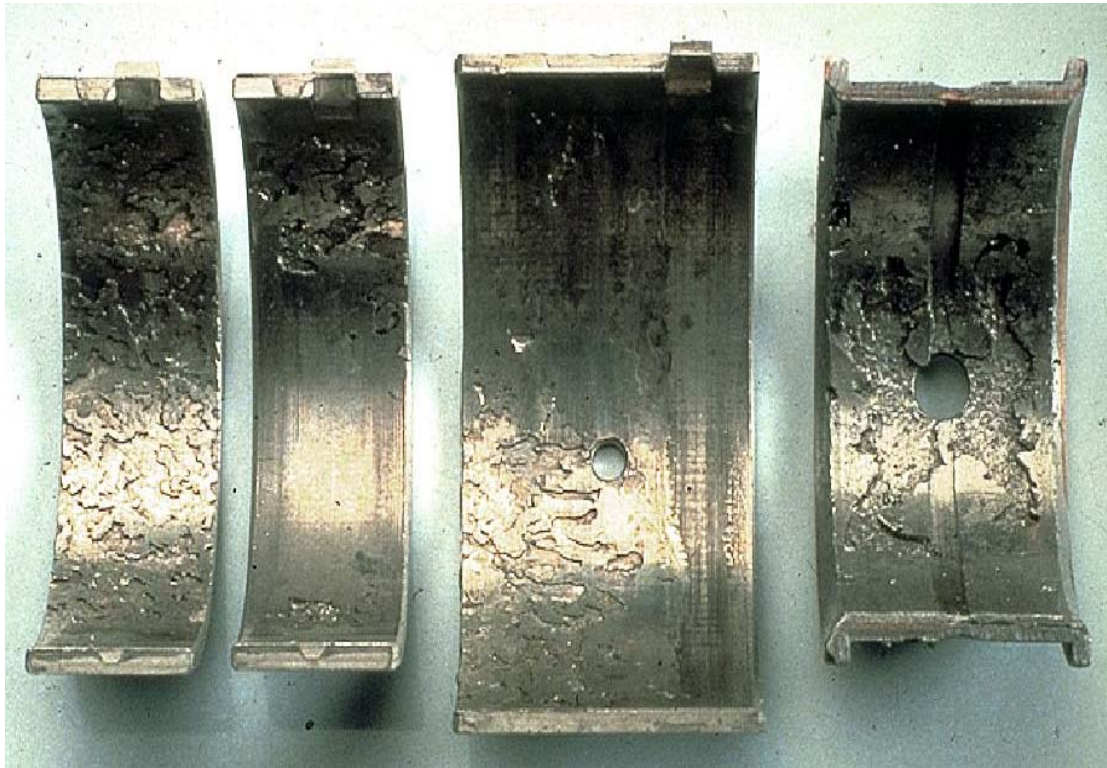
## Bearing lining material fatigue.

**Appearance:** bearing lining cracked with material missing, forming craters.

**Cause:** Incorrect bearing clearance, excessive compression pressures, "lugging" - caused by low speed high gear.

**Remedy:** Replace all bearings & check clearance. Flush out engine lubrication system, ensuring that all galleries are free from blockages/debris and replace oil and oil filter.

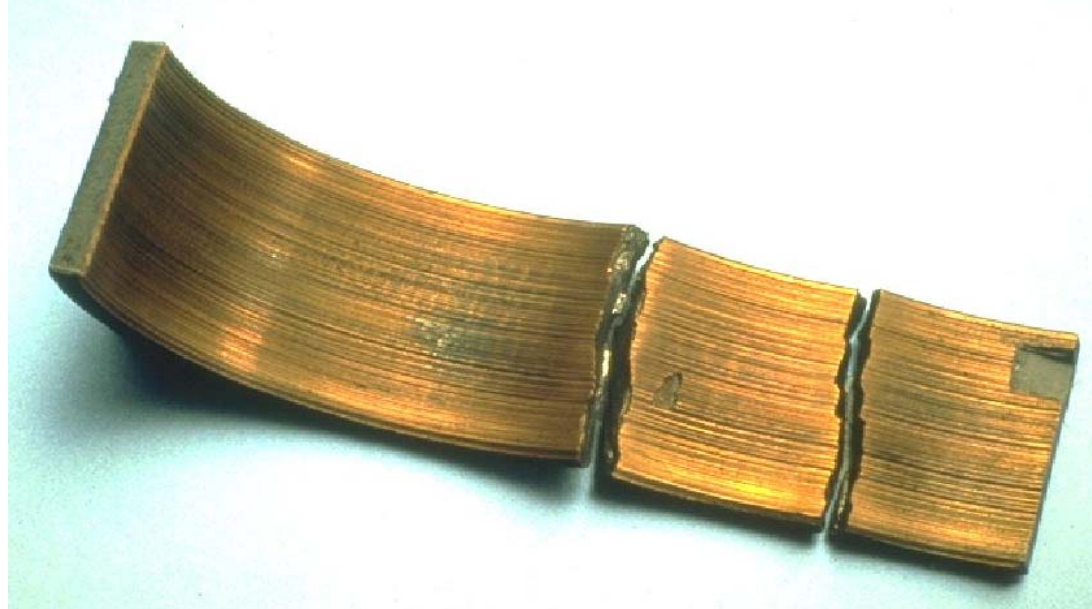
## Fatigue of steel-back:

**Appearance:** steel-backing of bearing cracked/broken.

**Cause:** Incorrect bearing clearance, excessive compression pressures, "lugging" - caused by low speed high gear - Overload conditions.

**Remedy:** replace all bearings & check clearance. Flush out engine lubrication system, and replace oil and oil filter.

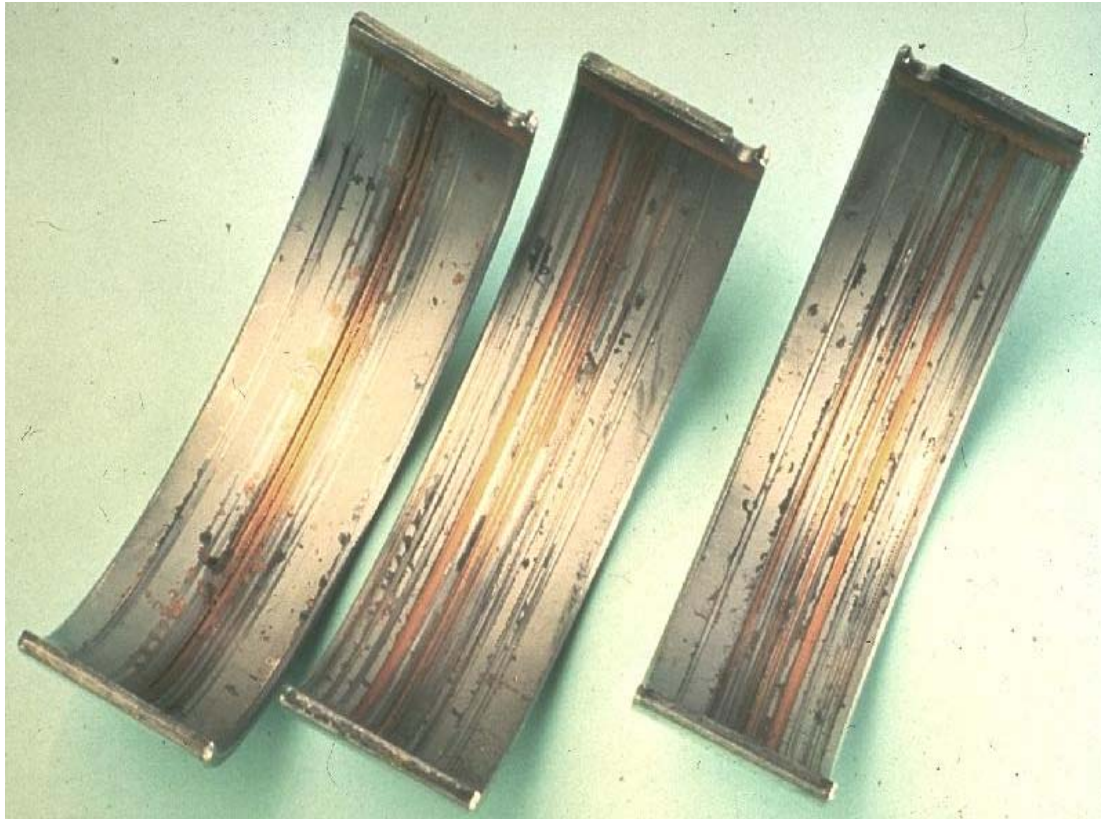
## Scored lining material:

**Appearance:** bearing surface is deeply scratched/scored..  
**Cause:** lubrication system contaminated with foreign particles.  
**Remedy:** flush out engine lubrication system, ensuring that all galleries are free from blockages/debris, replace bearings and regrind crankshaft if necessary. Replace engine oil & filter, prime lubrication system before initial start up.

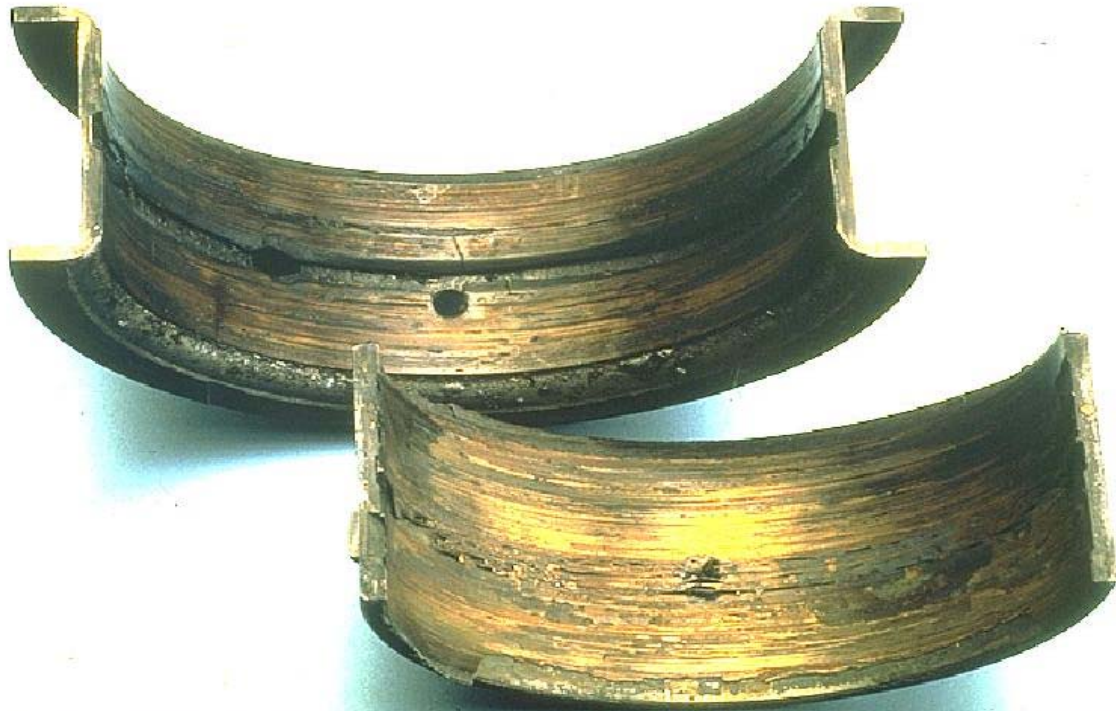
## Burnt/ wiped lining.

**Appearance:** bearing surface/lining material discoloured and wiped from backing material. Lining material often found extruded along edges of shell.

**Cause:** lubrication starvation, blocked oil passage, low oil level, misalignment, insufficient clearance etc.

**Remedy:** flush out engine lubrication system, ensuring that all galleries are free from blockages/debris, replace bearings and regrind crankshaft if necessary. Replace engine oil & filter, prime lubrication system before initial start up.

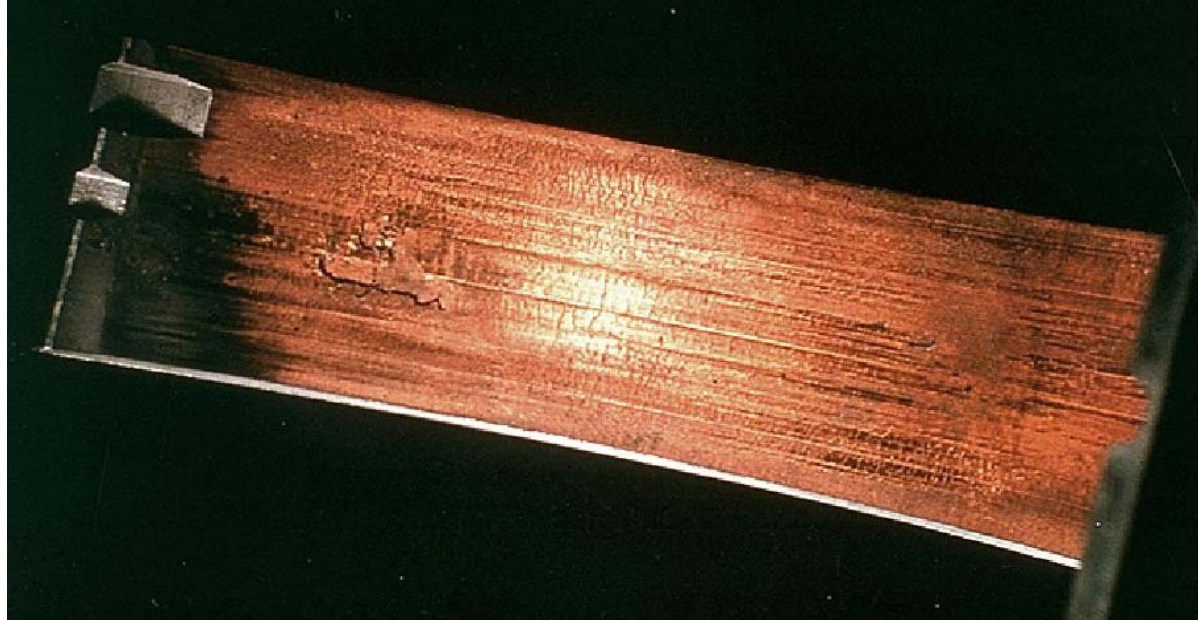
## Corrosion of lining material.

**Appearance:** bearing surface/lining material discoloured, darkened and often etched by chemical attack.

**Cause:** acid build up in engine oil due to: high sulphur fuel, use of "sewer gas", coolant contamination of oil, over-aged engine oil.

**Remedy:** flush out engine lubrication system, replace bearings and regrind crankshaft if necessary. Replace engine oil & filter, prime lubrication system before initial start up.
